Safety Alert – 27 March 2015

Power and Gas in Telco Ducts

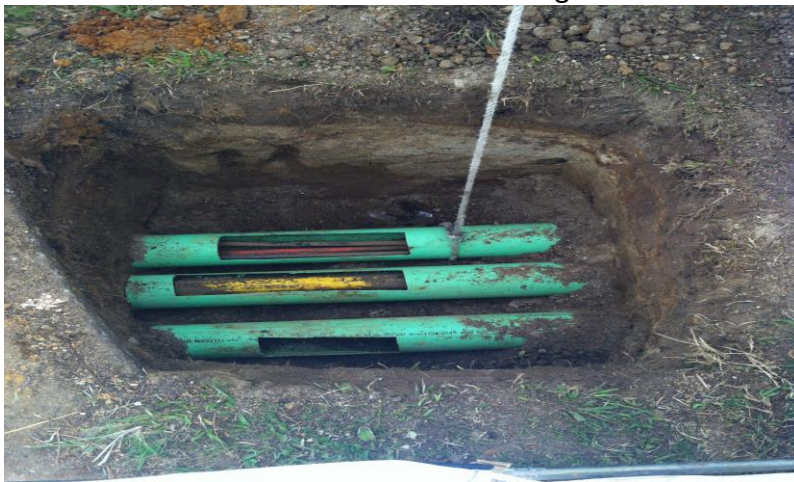
During installation of ducts for the Ultra-Fast Fibre project, a contractor had requested power mark outs. These were completed accurately and when the fibre contractor pot holed, all they could find at the kerb line were green telco ducts. They checked this with their Cat and Genny which indicated power cables were probably inside the ducts. A hammer was used to smash a hole in one of the ducts confirming the presence of power cables. This was then reported to the principal's supervisor who then contacted Chorus.

1. This is the second instance in Hamilton where power has been found installed in Telco ducts. The issue is historic circa 1995-2000 and caused by subdivision developers providing ducts under the roads for power installation. The issue has been masked in one area by the fitting of grey ends to the Telco ducts to hide that green ducts had been used for the road crossing.
2. Telco representative arrived on site and proceeded to cut slots into the ducts with a four inch hand held disk grinder

1. Treat all ducts as potentially containing live equipment whether it be power, gas or communications cables.
2. **Reinforce that anyone can stop any job at any stage when they believe there is a risk/hazard presenting itself, including stopping other companies staff.**
3. Telco service provider is investigating issue of the entry methodology to the ducts.
4. The identified ducts have been marked on WEL's GIS with the label (which appears on the service plans) "100 mm duct - in green Telco."
5. Discussion with Chorus over ducting.
